Technical Bulletin

NO. 9908

TOPIC: RESOLVING EXTERNAL MAGNETIC FIELD ERRORS **Models LKP, CM, FM, or CXM Equipment**

File TEC9908c (Replaces Technical Bulletin No. 727)

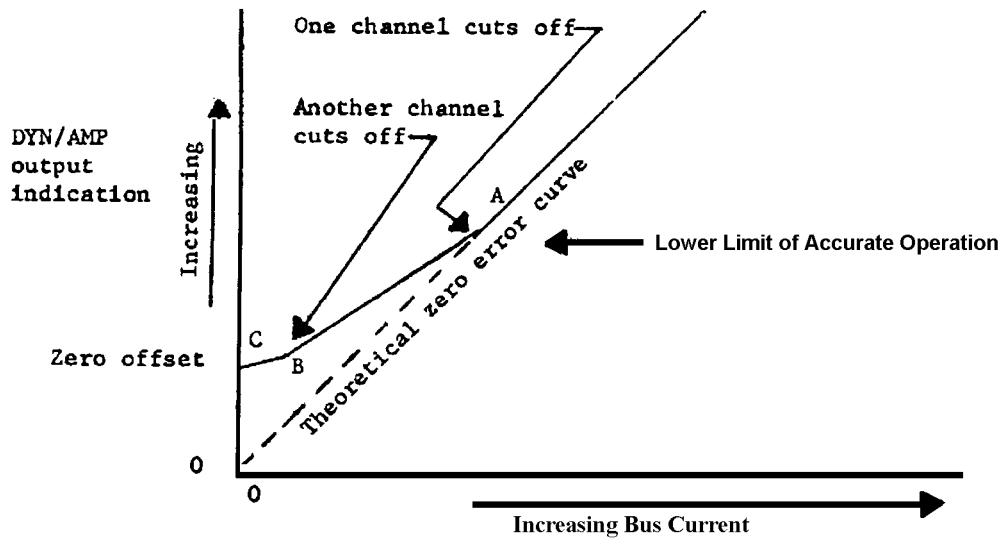
LOW END ERRORS

Now consider what happens as the internal bus current reduces to zero. The "I" vectors shrink to zero, leaving only the external magnetic field vectors to consider. As this happens, the feedback currents, and consequently the FB field vector, will decrease. Indeed, at some value of bus current, in channel 1 and in channel 4, the direction of the net input magnetic field will reverse. This reversal of the net input field direction is the condition (shown as point A in "Low End Errors" diagram) below which types LKP, CM, FM, CXM systems have errors, because their uni-directional amplifiers cannot force feedback current in the reversed direction to null out the field on this side of the measuring head.

The error will increase, somewhat linearly, below this point. There are break points in the curve as other channels cut off. The error will be maximum at zero bus current. Please note that the system is accurate for bus currents above point A.

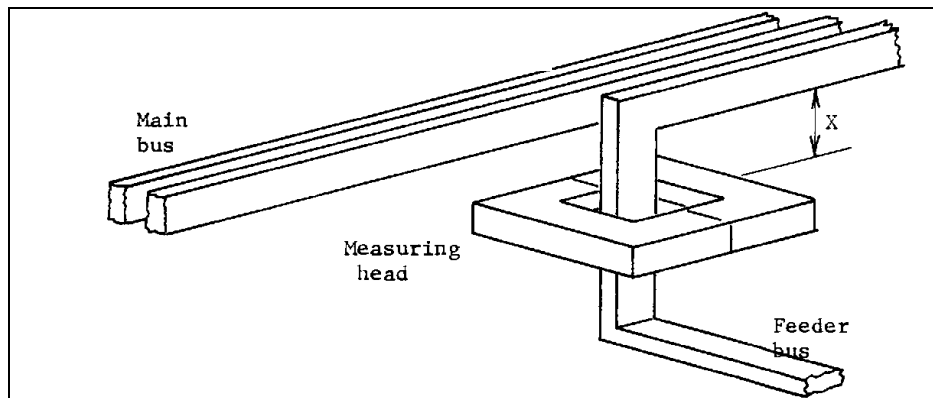
THE SEVERITY OF THE EXTERNAL MAGNETIC FIELD WILL REDUCE AS THE DIMENSION "X" INCREASES.

Often the measuring head is located near a 90° turn in the bus. Sometimes putting the measuring head beyond the elbow will help solve the problem.

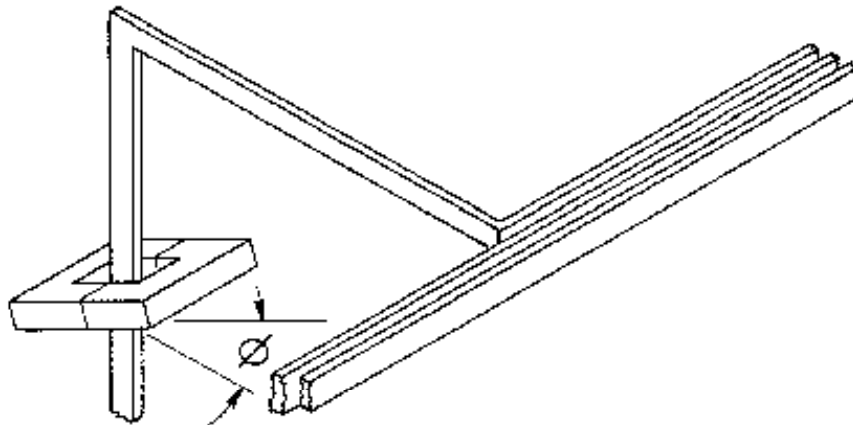
PLANE OF MEASURING HEAD INTERSECTS THE BUS GENERATING THE MAJOR EXTERNAL MAGNETIC FIELD.

It might be possible to tilt the head so that the external magnetic field does not have a component in line with either major core direction. This usually occurs when the extension of the plane of the measuring head intersects the center line of the main bus.
