Technical Bulletin

NO. 9908

TOPIC: RESOLVING EXTERNAL MAGNETIC FIELD ERRORS **Models LKP, CM, FM, or CXM Equipment**

File TEC9908c (Replaces Technical Bulletin No. 727)

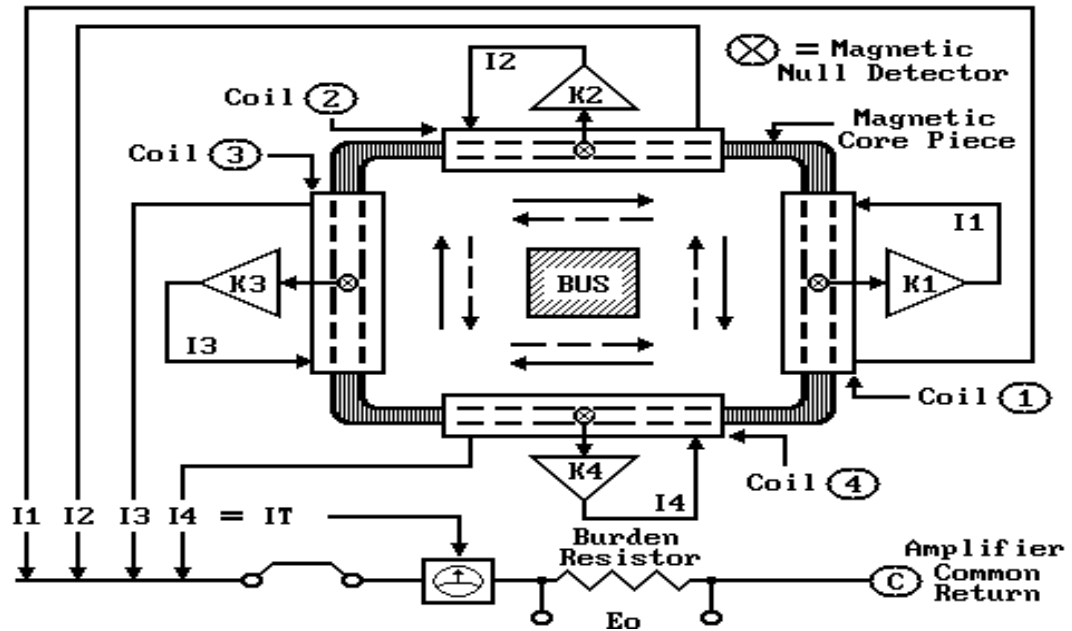
CURRENT MEASUREMENT SYSTEM

1. Current in the primary bus sets up a magnetic field (dotted arrow), which causes a flux in the measuring head core piece.
2. When a flux is present, the magnetic null detectors (X) generate a signal to drive the high gain current amplifiers (K₁, K₂, K₃, and K₄).

3. The dc current from each amplifier passes through coils wrapped around the core and sets up a field "equal and opposite" (solid arrow) to the bus current field.

4. Each detector - amplifier - coil combination acts as an independent current feedback system to maintain a condition of "zero flux" around the core piece path.

5. The sum of the amplifier currents (I₁, I₂, I₃, and I₄) is directly related to the primary bus current. The ratio of current in the bus to output current (I_t) is 5,000:1.

6. Moving the measuring head with respect to the bus causes the relative values of I₁, I₂, I₃, and I₄ to change. The total current, I_t, however, remains constant.

7. External magnetic fields are self-canceling around the measuring head loop. An external field will cause one current to increase with a corresponding decrease in the other channel circuits. I_t remains proportional to only the primary bus current.
8. Burden resistors, in series with I_t , can be inserted to develop a signal output voltage. The channel voltages automatically adjust to maintain the proper channel currents. I_t remains unaffected.
9. The closed-loop design dynamically corrects for changes in line voltage, component aging, and ambient temperature variations.

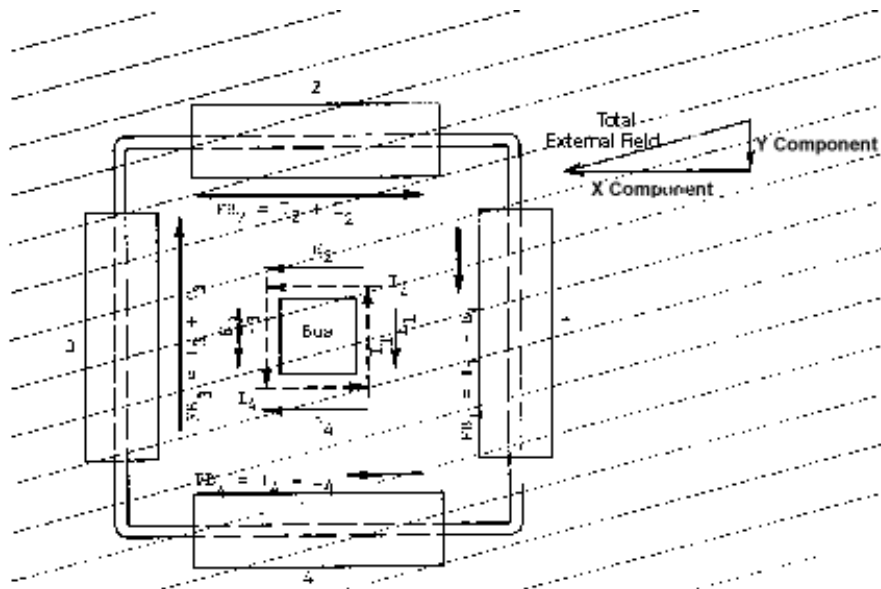
EXTERNAL MAGNETIC FIELD EFFECTS

If there were no external magnetic fields ($E_1 = E_2 = E_3 = E_4 = 0$), we would expect the feedback currents from each amplifier to be about equal. The net effect of the external field is a vector, which is additive on one side and subtractive on other sides of the measuring head. At the normal operating point, there is no problem; the additive and subtractive vectors cancel out around the loop of the measuring head. There may be a significant shift in the heat load caused by this external magnetic field. Channel 2 in diagram above is a good example where both the E and I magnetic fields are additive, causing one side to run much hotter than the other. However, all channels are operating in their normal dynamic range, so total cancellation takes place and the system is accurate.

Now consider what happens as the internal bus current reduces to zero. The "I" vectors shrink to zero, leaving only the external magnetic field vectors to consider. As this happens, the feedback currents, and consequently the FB field vector, will decrease. Indeed, at some value of bus current, in channel 1 and in channel 4, the direction of the net input magnetic field will reverse. This reversal of the net input field direction is the condition (shown as point A in "Low End Errors" diagram) below which types LKP, CM, FM, CXM systems have errors, because their uni-directional amplifiers cannot force feedback current in the reversed direction to null out the field on this side of the measuring head.
