FIELD MODIFICATION - NOTE 3

SYM.	REVISION			DRN./DATE	CK'S/DATE	THIS DRAWING AND ALL INFORMATION CONTAINED HEREIN, IS THE PROPERTY OF DYNAMP LLC, AND MAY NOT BE COPIED, REPRODUCED NOR DIVULGED TO UNAUTHORIZED PERSONS WITHOUT THE EXPRESS WRITTEN CONSENT OF Dynamp LLC. IT IS PROVIDED SOLELY FOR THE CONVENIENCE OF THE USER AND SHALL BE RETURNED UPON REQUEST.									
A	ECR-1758: AS BUILT; CORRECTED BALLOON NUMBERS AND QUANTITIES.			FEM/8-28-12	DE08-28-12	B/M NO./REF. O45807	<div><div>THIRD ANGLE PROJECTION</div><div>

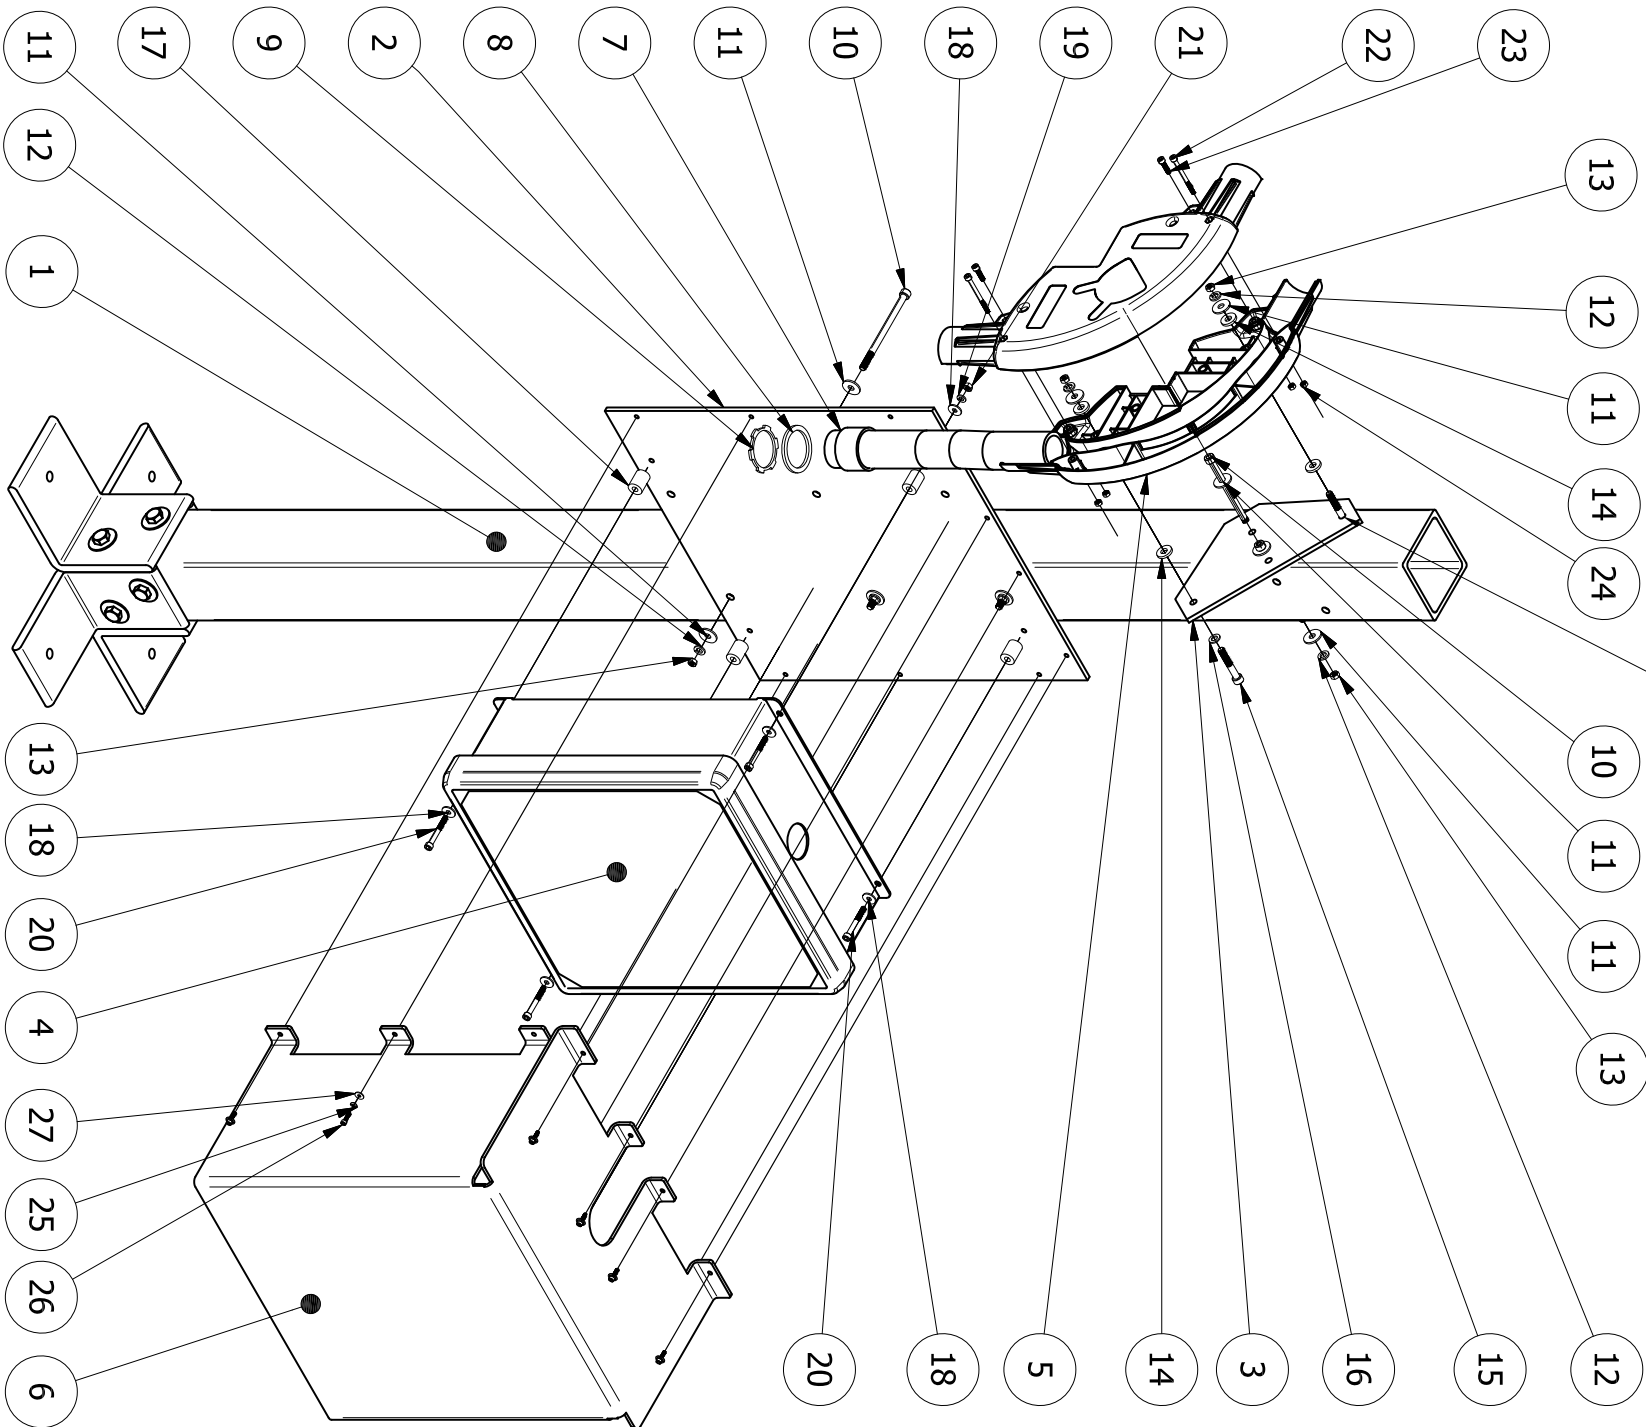
- 1- ANCHOR COLUMN TO GROUND. PLEASE REFER TO DRAWING 02B109298 FOR BASE HOLE-PATTERN, ORIENTATION, AND LOCATION OF PEDESTAL IN RELATION TO BUS BAR.
- 2- ATTACH MOUNTING PANEL (2) TO COLUMN AS SHOWN USING M8 BOLTS, WASHERS AND NUTS (10, 11, 12, 13). NOTE THE ORIENTATION OF THE PANEL - THE M4 HOLES IN THE PANEL SHOULD BE LOCATED ON TOP AND SIDES, BUT NOT BOTTOM. PANEL IS OFFSET TO THE LEFT OF THE COLUMN.

- 3- TEMPORARILY ASSEMBLE THE TOP BRACKET TO THE COLUMN USING M8 BOLTS AND NUTS (10, 13). NOTE THE ORIENTATION OF THE BRACKET AND MOUNTING HOLES USED (1st AND 3rd HOLES FROM THE BOTTOM OF THE BRACKET), USING THE TOP LEFT CORNER HOLE ON THE BRACKET, AS A REFERENCE, DRILL SMALL HOLE HORIZONTALLY THE ROUGH THE FRONT AND BACK SIDES OF THE COLUMN. REMOVE THE TOP BRACKET AND ENLARGE THE HOLE ON THE COLUMN TO 17MM. THIS HOLE WILL BE THE CLEARANCE FOR THE TOP CORNER ASSEMBLY HOLE. TEMPORARILY ASSEMBLE M8x50BOLT, WASHER, RUBBER WASHER AND NUT (14, 15, 16, 13) ON THE TOP HOLE OF THE BRACKET. REASSEMBLE TOP BRACKET (3) TO COLUMN AS SHOWN, USING M8 BOLTS, WASHERS AND NUTS (10, 11, 12, 13).

- 4- ATTACH COMPENSATION BOX (4) TO BACK PANEL USING SPACERS (17), AND M6 BOLTS, WASHERS, AND NUTS (18, 19, 20, 21).
- 5- APPLY A THIN COATING OF RTV TO THE RUBBER WASHERS AND ATTACH THE CORNER TO THE UPPER BRACKET USING THE M8x50 SCREWS, RUBBER WASHER, STEEL WASHER AND NUT (15, 16, 14, 14, 11, 12, 13) IN THE ORDER SHOWN ON DRAWING. TIGHTEN THE NUT UNTIL THE RUBBER WASHER IS COMPRESSED SLIGHTLY. DO NOT OVER TIGHTEN AS IT WILL DAMAGE THE PLASTIC CORNER. TO PREVENT LOOSENING OVER TIME, USE OF LIGHT DUTY THREAD-LOCK IS RECOMMENDED.

- 6- ATTACH THE THREADED CONDUIT COUPLING (7) AND RUBBER SEALING WASHER (8) TO THE COMPENSATION BOX USING THE LOCK NUT (9). THE LOCK NUT IS INSTALLED INSIDE THE COMPENSATION BOX. TIGHTEN THE LOCK NUT SUCH THAT THE SEALING WASHER IS COMPRESSED IN HALF.

- 7- ATTACH LKCO CORNER COVER USING M5 SCREWS, AND NUTS (22, 23, 24). ONCE THE SENSOR ROUTING IS COMPLETE. SEAL THE EDGES OF THE CORNER ASSEMBLY WITH WEATHER PROOF RTV AND REATTACH. SEAL THE OPENING OF THE LARGER CORNER MOUNTING HOLES (M8) AS WELL TO PREVENT WATER INGRESS INTO COMPENSATION MODULE.

- 8- ONCE THE WIRING AND SENSOR INSTALLATION IS COMPLETE, ATTACH THE COVER (6) TO THE BACK PANEL USING M4 SCREWS, CURVED WASHERS, AND FLAT WASHERS (25, 26, 27).
